Manhole Inspection Summary

Manhole # S25C__017MH

Location Address: **1212 FRANKLIN ST**

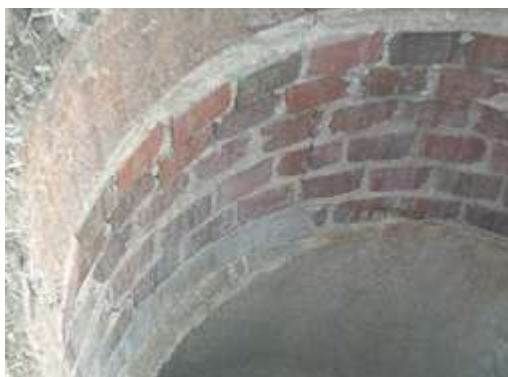
Defect 1

Comments **HUGE CRACK ON CORBEL**

Condition: ☐ Sound ☒ **Cracked** ☐ Root Intrusion ☐ Loose Brick ☐ Deteriorated

CRACKED CORBEL

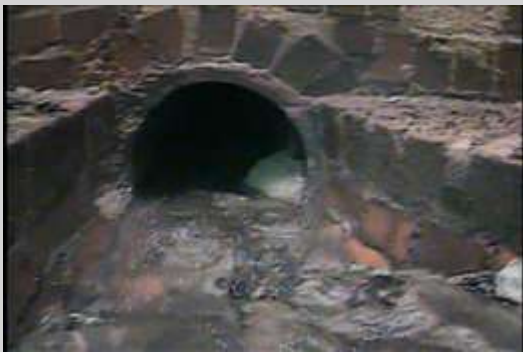
12 O'Clock Outflow

12 in. Circular Gravity Sewer
Pipe Out @ 12 O'Clock

Pipe Height: **10.8** (in.) Rod and Bar (Angled)
Pipe Material: **Clay** ☐ Pipe Lined
Invert Depth: **11.19** (ft.) Flow Characteristics: **Slow**
Deposits: ☐ None ☐ Mud ☐ Sludge ☒ **Debris** ☐ Grease
Silt Depth: **3** (in.) Deposits Extent: **Medium**
Infiltration: **None** Pipe Seal Cond: **Sound**

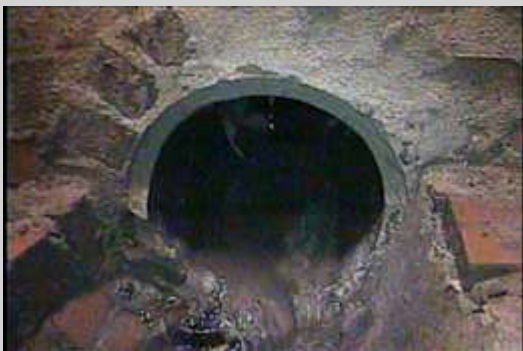
3 O'Clock Inflow

8 in. Circular Gravity Sewer
Pipe In @ 3 O'Clock

Pipe Height: **8.4** (in.) Rod and Bar (Angled)
Pipe Material: **Clay** ☐ Pipe Lined
Invert Depth: **10.60** (ft.) Flow Characteristics: **Slow**
Deposits: ☐ None ☐ Mud ☒ **Sludge** ☐ **Debris** ☐ Grease
Silt Depth: **2** (in.) Deposits Extent: **Light**
Infiltration: **None** Pipe Seal Cond: **Sound**

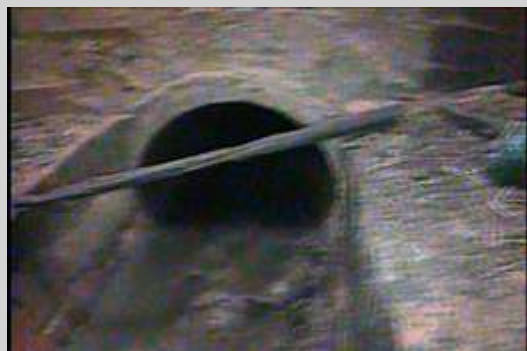
6 O'Clock Inflow

12 in. Circular Gravity Sewer
Pipe In @ 6 O'Clock

Deposits: ☐ None ☐ Mud ☐ Sludge ☒ **Debris** ☐ Grease

Silt Depth: **3** (in.) Deposits Extent: **Light**
